UNDERWATER BRIDGE INSPECTION REPORT

STRUCTURE NO. 36522

BIG FORK RIVER

DISTRICT 1 - KOOCHICHING COUNTY

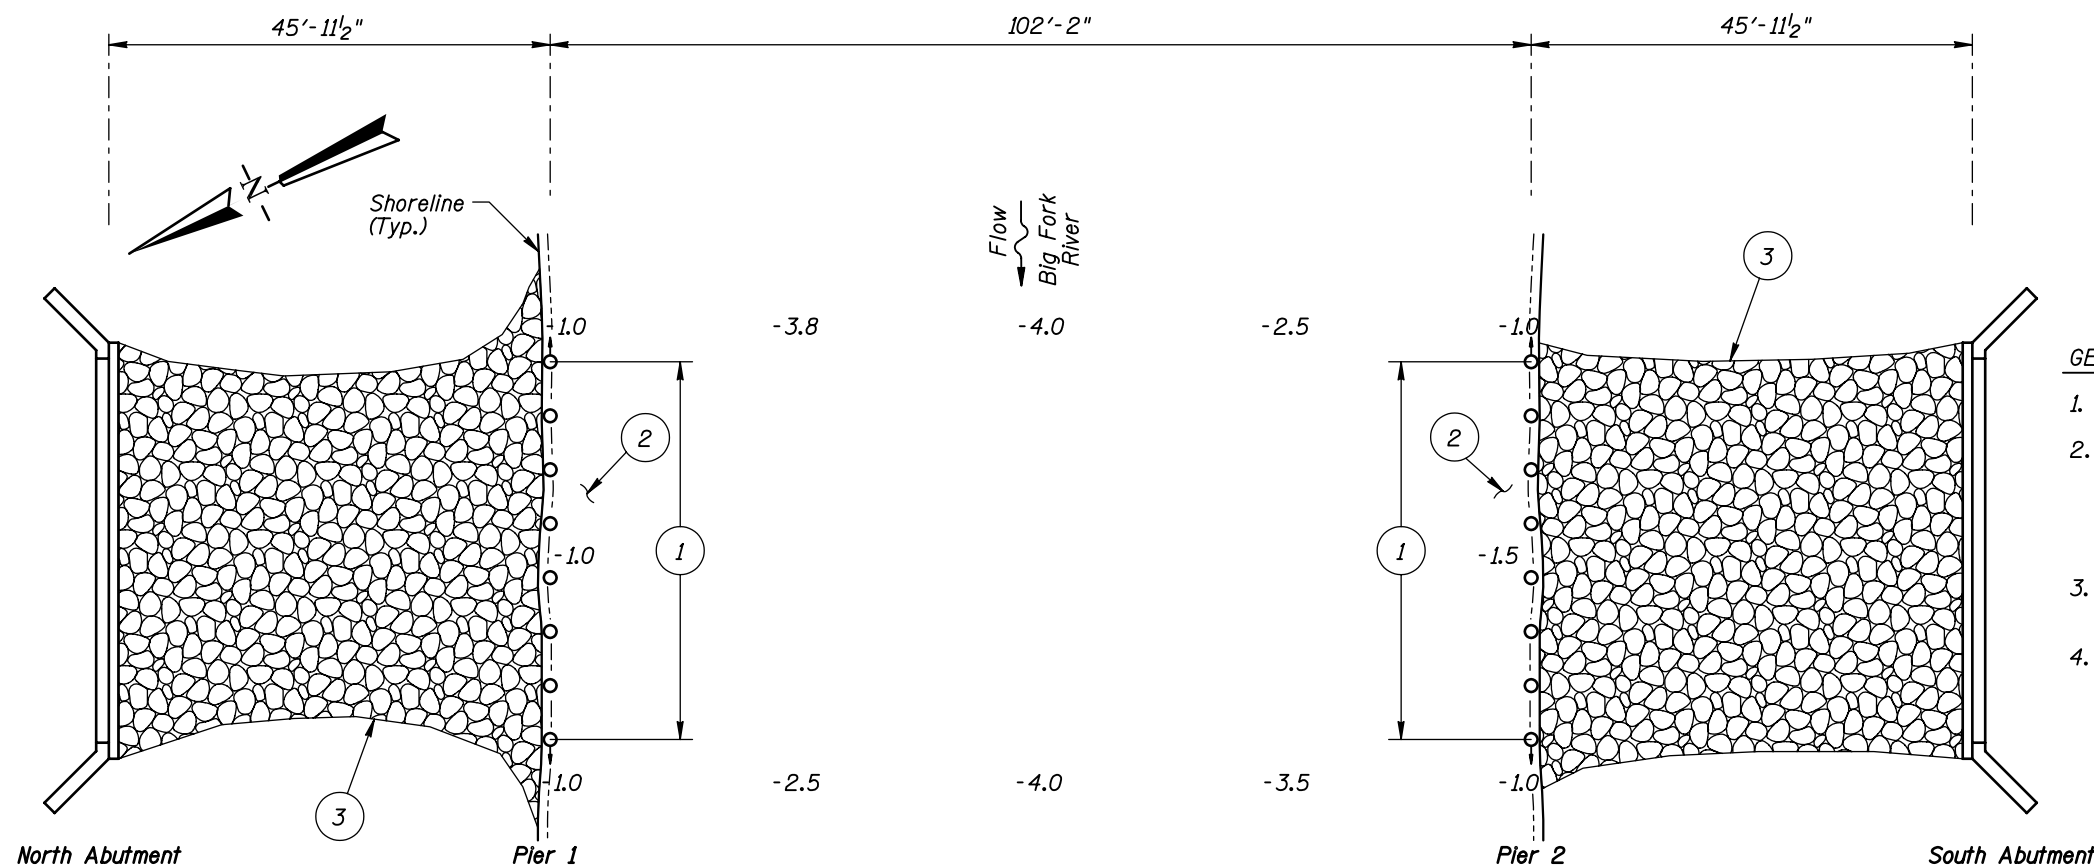
Date: AUG. 2002
Scale: NTS
Figure No.: 1

- 1 The steel pipe piles exhibited coating failure with light corrosion over 10 to 25 percent of their surface area from 1.5 feet above the waterline to the channel bottom.
- 2 The channel bottom consisted of 1 to 2 foot diameter riprap with no probe rod penetration.
- 3 The embankments were well armored with 1 to 2 foot diameter riprap.

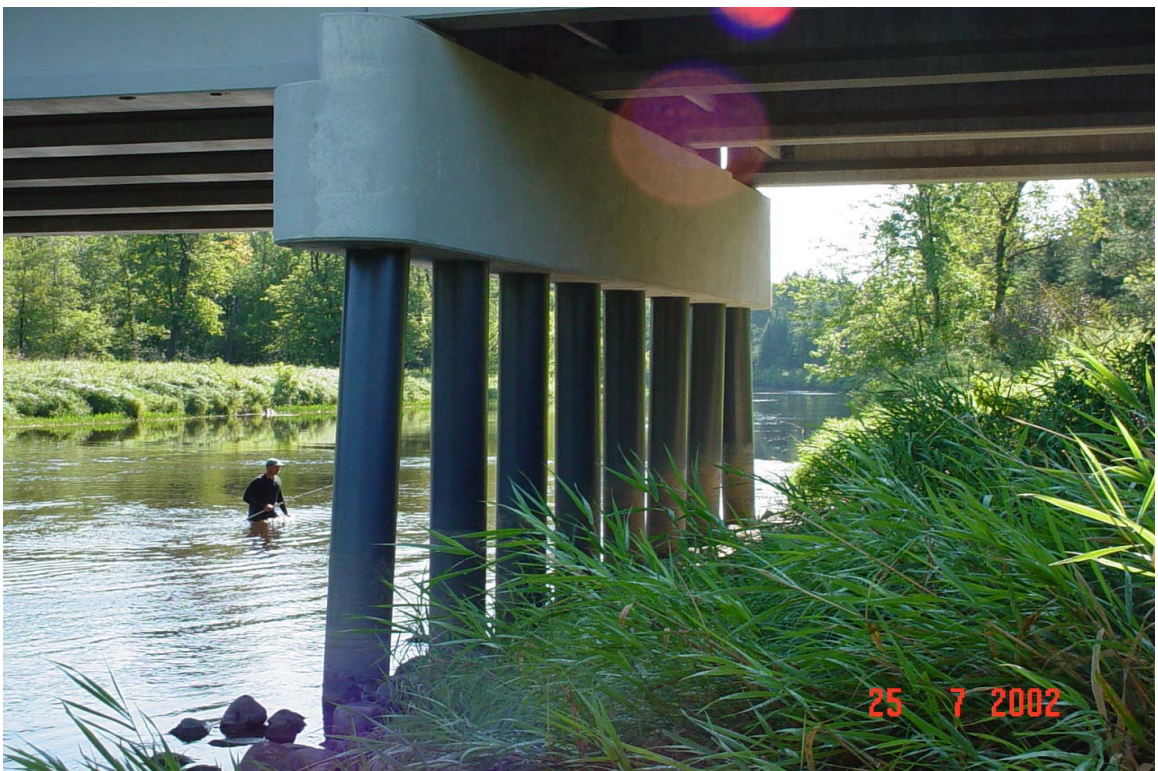
- (A) The steel pipe piles exhibited coating failure with light corrosion over 10 to 25 percent of the surface area from 1.5 feet above the waterline to the channel bottom.

Photograph 2. View of Pier 2, Looking Northeast.

- (A) Reinspect all substructure units underwater within the normal maximum (NBIS) interval of five (5) years. During low water levels, substructure units could be inspected using waders.

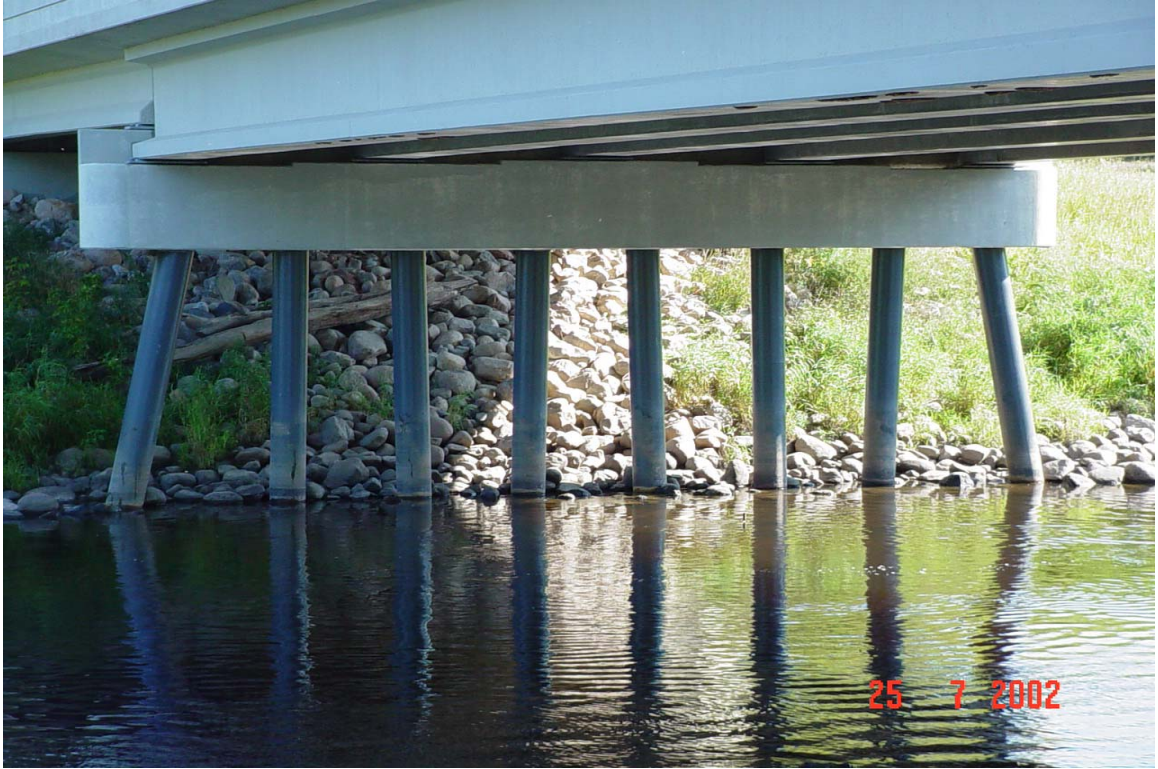
Photograph 3. View of Pier 1, Looking Northeast.
